Imagery Analysis Report

Gorkiy Shipyard 112

Gorkiy, USSR

GORKIY SHIPYARD 112
GORKIY, USSR

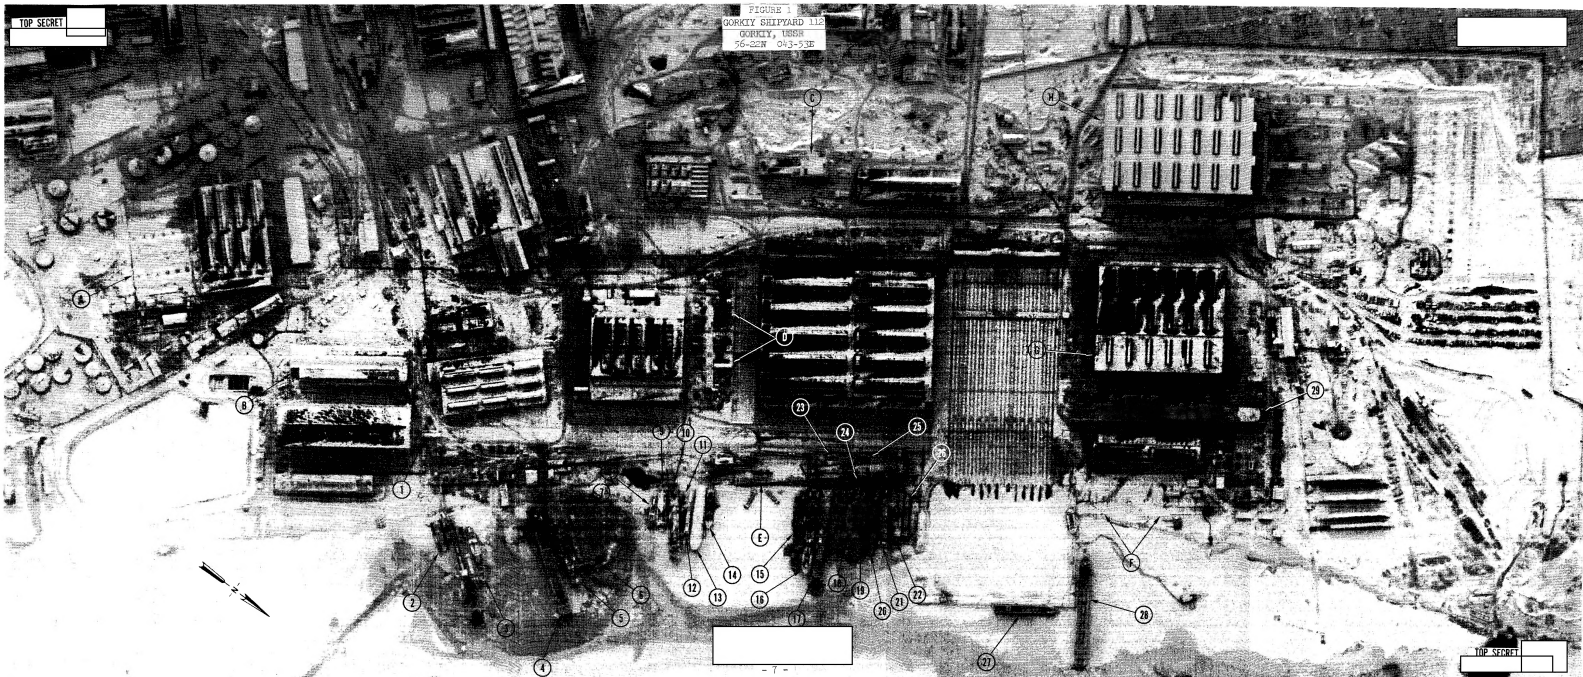
KEY TO NUMBERED ANNOTATIONS ON FIGURE 1

1. Probable hydrofoil (LOA approx 85'*).
Identification is based on the vertical fin on the stern, the dark-toned area on the bow (almost all hydrofoils of this approximate size which have been observed in the Gorkiy area have had a similar dark-toned area on the bow), overall hull outline, and the approximate size. This probable hydrofoil is probably new construction. Imagery possibly equating to an unidentified small craft (approximately 65 feet long) is visible along the port side of this hydrofoil.
It is believed that the large building to the rear of this craft is probably being utilized as a small craft construction hall. The launching of these craft is probably accomplished by a set of possible launching rails (the vessel at annotation 1 is probably resting on these rails) which extend from the building to the large transverser at the north end of the yard. There the tracks are aligned with the launching cradle, and the vessel is then launched into the launch basin.

2. Possible float/floating crane (overall dimensions approximately 125 x 45').
3. ZEYA Class YRSN (LOA approx 240').
An unidentified boat (LOA approx 40') is positioned on the deck, starboard of centerline and just forward of the aft superstructure. This is the first time a ZEYA Class has been observed carrying such a boat.

4. Unoccupied transporter dock (LOA approx 435').
5. Possible APL/YR fitting-out (could not be measured).
Poor image definition in this area of the yard precludes further interpretation of this vessel.

6. Small floating crane.

7. Rectangular YRSN (could not be measured).

8. Three-hatch barge (LOA approx 135').

9. SORMOVICH Class hovercraft resting on a large float.

10. Probable APL/YR (could not be measured).

11. Unidentified SS (visible waterline length approx 185').
A unique stepped sail, large shack-like structure on the bow, and the approximate waterline length equate favorably to the submarine previously med-moored at the northernmost end of the main quay.

12. One rectangular YRSN (LOA approx 190').

13. River passenger vessel (LOA approx 270').
A similar vessel was positioned just north of the launch basin.

14. Unidentified auxiliary (LOA approx 175').

15. Possible APL/YR (LOA approx 315').

16. Possible APL (could not be measured).

17. Large covered transporter dock (could not be measured).
This is probably the same dock that was positioned just outside of the launch basin caisson. Keel blocks were then visible on the dock floor.

The unidentified submarine is no longer visible in the yard. Since three large transporter docks were in the yard and there are still three large docks on this coverage, it is believed that the above referenced unidentified SS is now in the covered transporter dock. The leading edge of a large rectangular object

[redacted] protrudes through the covering of the transporter dock approximately 240 feet from the stern of the dock. This object could equate to a scaffolded submarine sail.

18. Two-hatch barge (LOA approx 135').

19. Floating crane.

This crane appears to be working in the area of the sail of the "J" Class SSG at annotation 20 below. [redacted]

20. "J" Class SSG (LOA approx 280').

It cannot be discerned whether this submarine is fitted with a sail. The floating crane at annotation 19 above obscures the sail area. This is believed to be the third "J" Class SSG launched

21. Large probable fitting-out float.

22. Fitting-out barge.

23. Unidentified object (LOA approx 40').

This object has a very broad rounded leading edge, approximately 10 feet wide, which tapers back to a width of approximately five feet at the trailing edge. The configuration of this object does not appear to resemble either of the previously identified submarine sails observed in this area of the yard. [redacted]

24. Five-hatch barge (LOA approx 160').

25. Possible scaffolding.

[redacted] this scaffolding was occupied by a probable "J" Class SSG sail. Photography [redacted] revealed that

the "J" Class sail had been removed from the scaffolding and was resting approximately 50 feet closer to the transverser than the scaffolding, which had not been moved. On this coverage, the "J" Class sail is not visible in the area and may have been placed on the recently launched "J" Class SSG, at annotation 20 above.

26. Rectangular YRSN (LOA approx 190').

27. Small transporter dock (LOA approx

28. Unoccupied large transporter dock (LOA approx

Five unidentified objects, possibly equating to keel blocks, are visible on the floor of the dock. This is probably one of the two large docks moored how-
ever, this dock is not fitted with the athwartships walkway/brace extending between the tops of the dock walls forward of amidships as were the two docks referenced above. The walkway/brace may be a removable or temporary structure.

29. SOVETSKI AZERBAIJAN Class train ferry under construction (LOA of completed portion approx 415').
The bow section is not yet in place. Most of the train deck is now in place. Two large rectangular holes are visible in the area of the machinery spaces.

- A. Unidentified building undergoing expansion.

No discernible progress has been made

- B. Two-bay shop-type building under construction.

No visible progress has been made on the still incomplete south-east corner of the building

- C. Unidentified building undergoing expansion.

This building appears to be structurally complete; however, scaffolding is still visible on the northeast side and the end of the new section. There is no evidence of snow melting on the roof of the new section indicating that the new section is not yet heated.

- D. Open storage area.

Numerous submarine hull sections and frames are visible in the area. A large rectangular light-toned object similar to, and in the same position as, the large rectangular light-toned object observed

- E. New quay extension.

Construction continues on the new extension.

- F. Probable quay under construction.

No discernible progress has been made on this site

- G. Construction hall under construction.

The roof of the third bay now appears to be structurally complete. Melted snow on the roof of the first two bays suggests that these bays are now heated and could be functional.

- H. Large fabrication/construction hall under construction.

roughly 115 feet of roof section has been added to the northernmost end of the building and, in addition, nearly all of the westernmost bay has been roofed.
